"The COST Effective Answer To Concrete Corrosion"

June 2010 ISSUE 1

Recognizing Distressed Concrete Tank Walls

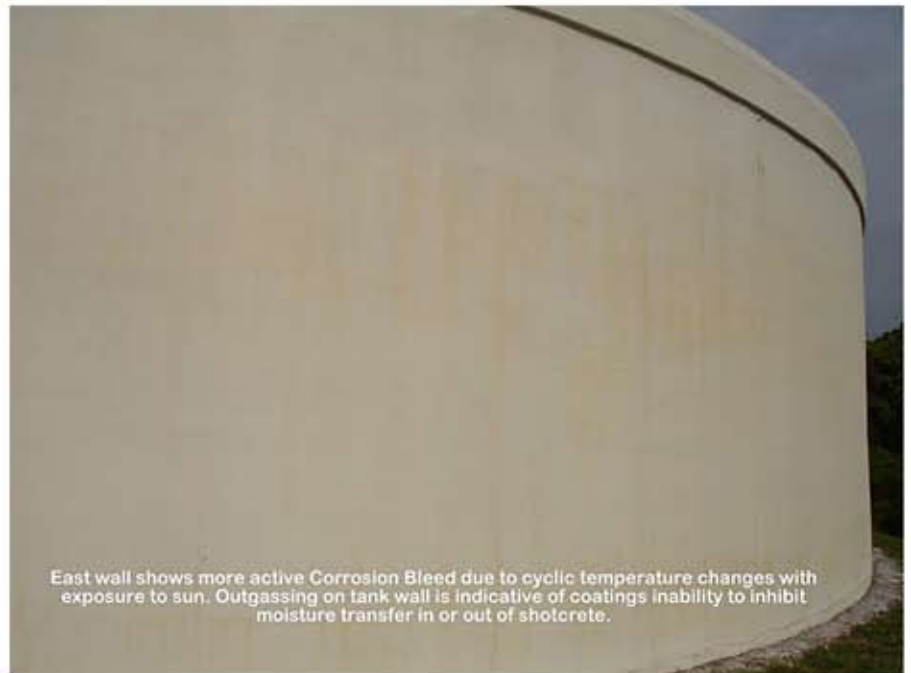
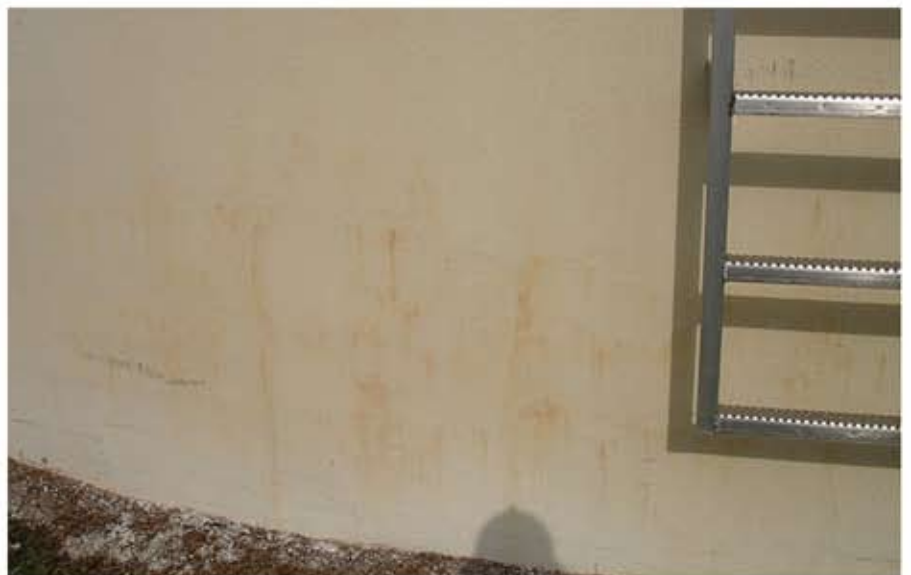
The first and most apparent sign of a problem is the brownish discoloration to the painted white surface of the tank indicating that contaminants on the surface are either leaching through the coating or being deposited on the surface from atmospheric sources. Note that the discoloration is most prevalent on the lower 1/2 to 2/3rds of the wall. This is an indication that a high moisture content of this concrete matrix exist in the lower wall levels due to gravity causing the moisture to wick down the wall interior and migrate out through the coating to discolor the surfaces.

Another confirmation of this condition is a more pronounced concentration of stain at Micro-Crack locations at these lower wall levels.

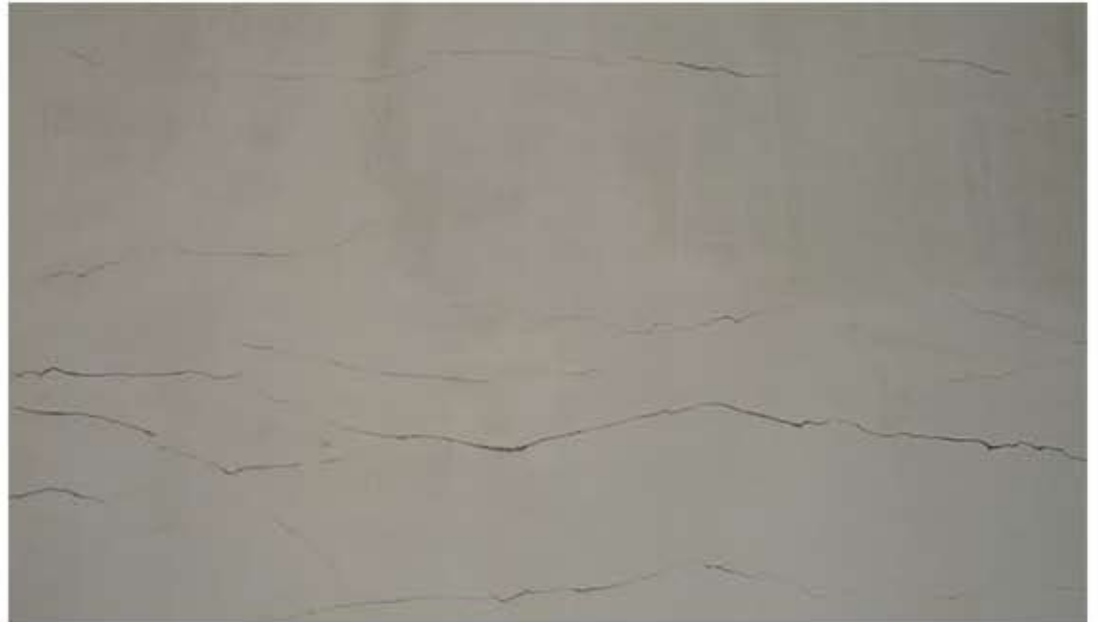
No information was available concerning ASTM C642 Testing (Boiled Water Absorption) that may have been accomplished when this tank was constructed, however it is noted the applied coating is allowing moisture migration out to the atmosphere and conversely permitting contaminants to enter the matrix in the same manner. The tank wall substrate is not waterproofed and is responsible for contaminants and chemistry to

migrate in and out of the structure. This is evident by noting that the wall surface facing to the East is more discolored than others. The rising sun and associated heat promote a cyclic wet-dry condition every day. As the surface heats, moisture within the wall evaporates from the surface and as it cools down humidity and rains are being absorbed back into the substrate. This free transfer of moisture allows airborne contaminants to migrate inward and internal chemistry of the concrete to migrate out where it reacts to form a host of unwanted surface conditions.

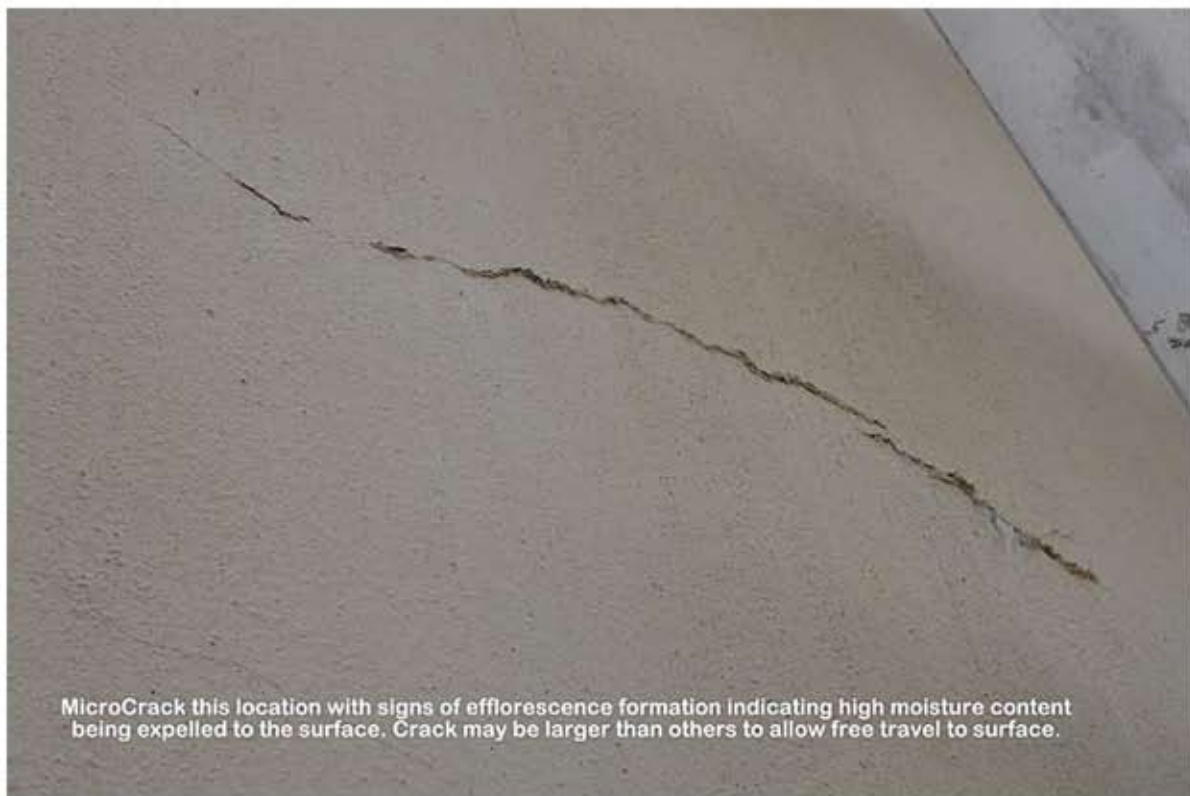
Efflorescence formations at several locations demonstrate a more active outward migration at Micro-Crack or Hydraulic Stress Fractures. Hydraulic action of filling a tank such as this will result in larger voids than shrinkage or curing cracks and offer an easier path for this outward migration if the substrate has not been waterproofed. A photograph of the tank wall top surface demonstrates vapor emissions to the vertical surfaces below. A larger crack or void carries more internal chemistry and moisture to these cracks where it is able to react freely with the atmosphere.

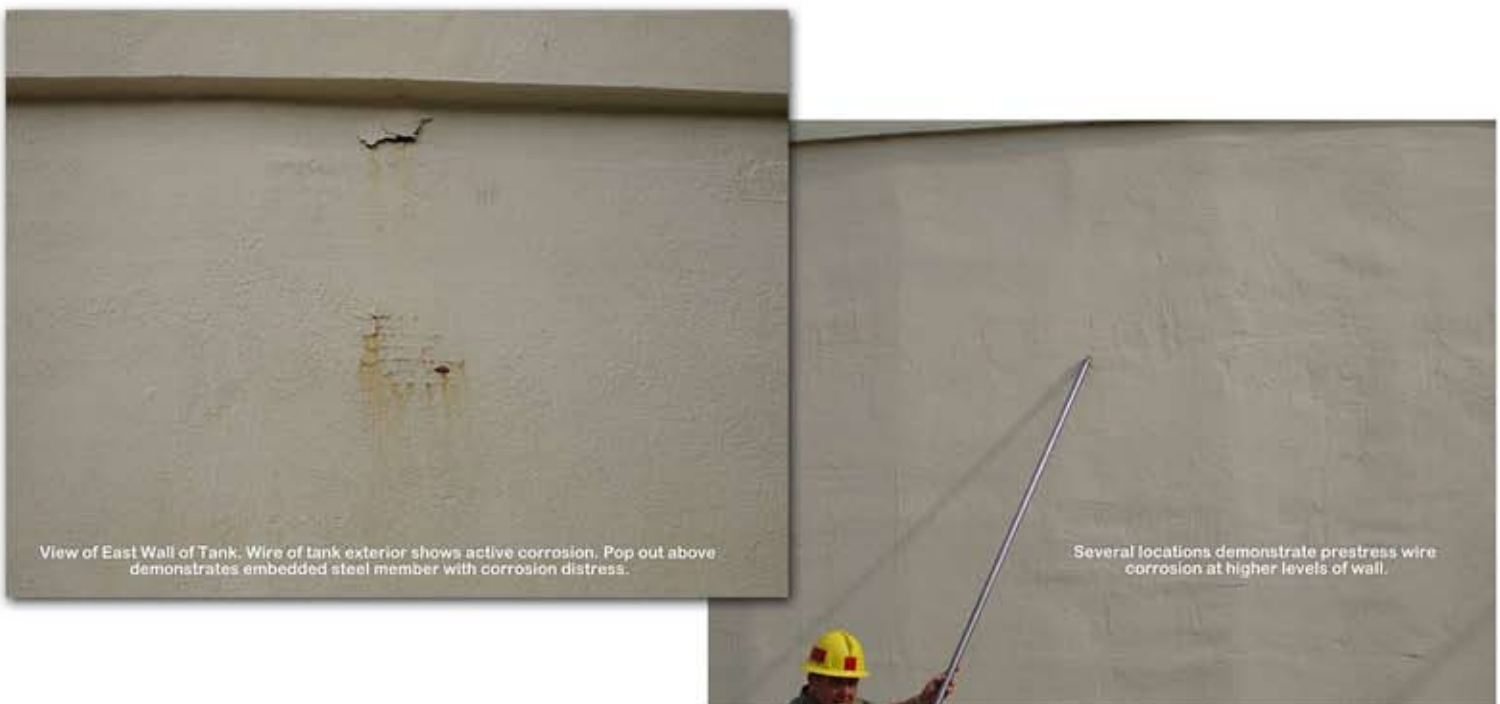
Samples of spalled concrete taken from the “Pop-Out” areas revealed severe carbonation at the depth of the steel and a pH of 5 at these levels. The Passivating layer on this steel has been compromised with these low pH levels allowing corrosion cells to form on the steel surfaces. Left untreated the corrosion, at this stage will advance rapidly requiring a more extensive repair/mitigation program. To compound these problems, pulverized samples from the “Pop-Out” areas also indicated unmeasured amounts of Sulfuric Acid in the samples. (Samples Not of a Volume to Allow Quantified Testing parameters)

It is believed that that Sulfuric Acid contaminants have been induced to these porous surfaces that were not waterproofed prior to a cosmetic coating being applied. Two digesters are located upwind of this tank allowing Hydrogen Sulfide to be wind driven to the tank wall where it is absorbed into this substrate exacerbating an already low pH caused by carbonation. Depth of cover issues, pervious substrate and the lack of a protective waterproofing system all play a role in the premature corrosion of the tank.

Early recognition of conditions such as this will allow for preventative steps to halt the corrosion and restore the concrete to a near new condition, thus avoiding a more complex and expensive repair. In this case, the concrete in the obvious areas of corrosion of steel will require removal. Steps to restore pH levels to above 12 should be taken in order to reestablish the Passivating layer on the embedded steel members. Realkalization could be in the form of electrochemical treatment or a wash to the surface. Post treatment pH testing should be accomplished prior to further work on the surface profiles. Patching or placement of shotcrete should be accomplished to allow sufficient depth of cover to offer protection against future corrosion cell formation.

Waterproofing this tank wall should be a priority after the repairs are complete. This will serve to reduce moisture and oxygen available to the concrete matrix. [Two of the essentials for corrosion cell formation]. A waterproofed surface will not show signs of chemical migration out to the surface and will prevent moisture/contaminate intrusion as well as Carbonation of the restored surface.
